# *City Council*
# *Special Meeting Agenda*
## *Joint Meeting of the City Council and the Parks, Arts & Recreation Commission*

A. Request to accept the Columbia Park Master Plan report and create an ad hoc committee consisting of two (2) Council Members and three (3) Parks, Arts, & Recreation Commission Members who will conduct a more thorough evaluation of the options, seek community input, and provide Council with a recommendation at a future Council meeting (*Van Guilder/Packwood*)

The following report is a summary of the existing conditions, code violations, deficiencies and proposed improvements for rehabilitation of the Columbia swimming pool, sprayground, and their respective equipment. The scope of this report includes the swimming pool, swimming pool deck areas, sprayground, sprayground deck areas, and swimming pool mechanical equipment. It excludes the structural integrity of the swimming pool shell and appurtenances as well as handicap accessibility in path of travel to the swimming pool area, sprayground area, and within the adjacent buildings. It also excludes mechanical equipment for the sprayground as access to that equipment was not provided during Aquatic Design

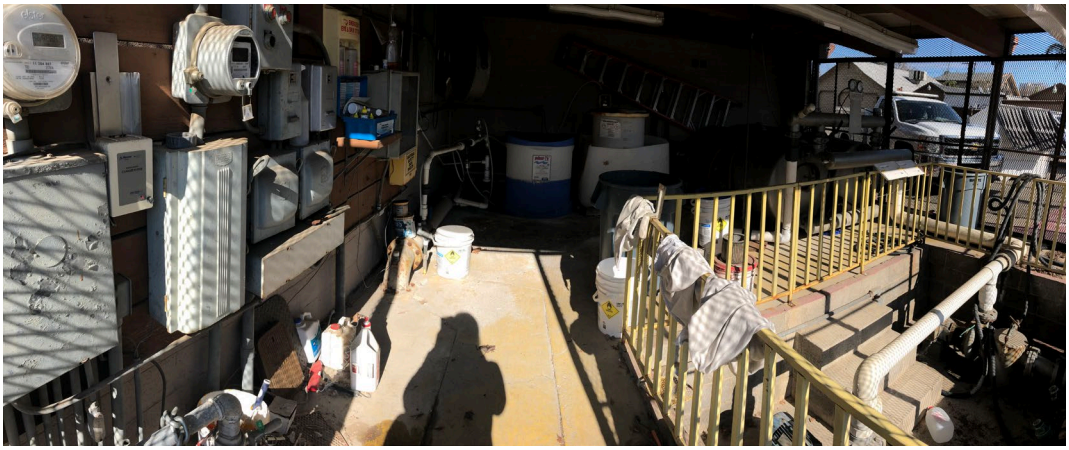
*Swimming Pool Mechanical Enclosure*

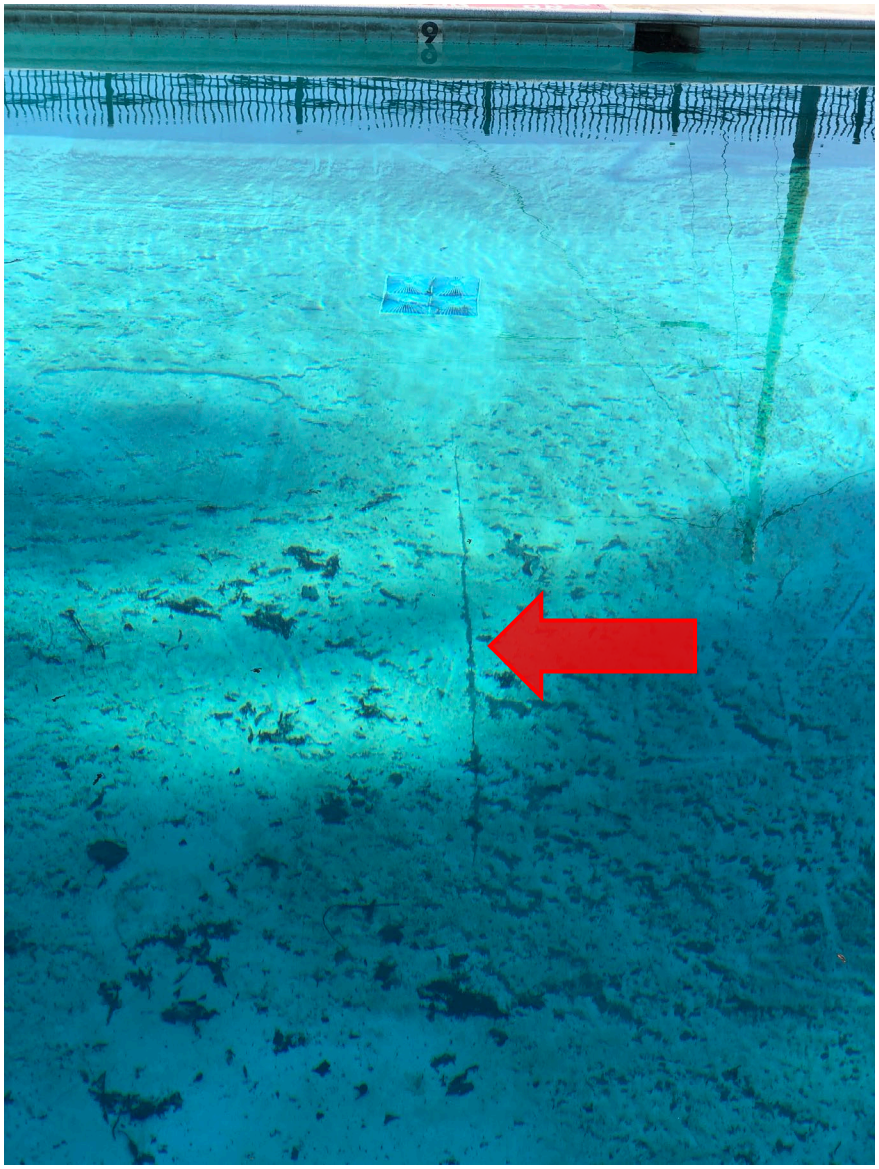
The surface of the swimming pool is showing signs of age. Staff report the surface was last replaced in 1999. The National Plasterers Association states that swimming pool plaster should be expected to last between 12-15 years under normal conditions. In several locations the swimming pool surface has delaminated, spalled, or otherwise separated. This results in unsafe conditions on the surface where sharp edges exist which could result in feet, hands, or other skin being cut or torn when in contact with the surface. The current porous plaster finishes could harbor pathogen growth, creating a further health and safety concern. Lastly, the state of the current plaster may create a condition where water is closer to the underlying structure of the swimming pool shell and could result in further oxidation and deterioration of the steel rebar which can increase the risk of leaks and structural failure of the pool shell. The plaster finish on the swimming pool is in violation of Title 24, Chapter 31B:

*Linear Crack in Plaster Finish*

The pool finish should be replaced. The industry standard is to use a quartz-based plaster and tile to finish the pool. The following estimate includes removal of all existing previous pool finish to bare concrete and the installation of a new plaster and tile finish. This estimate also assumes the underlying bare concrete is in good condition and does not need replacing.

**(Estimated Cost $354,500.00)**

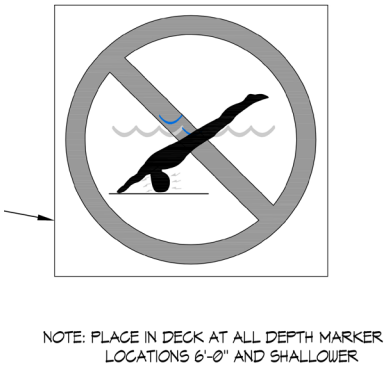
*Sample Design of "No Diving" Tile Graphic Marker*

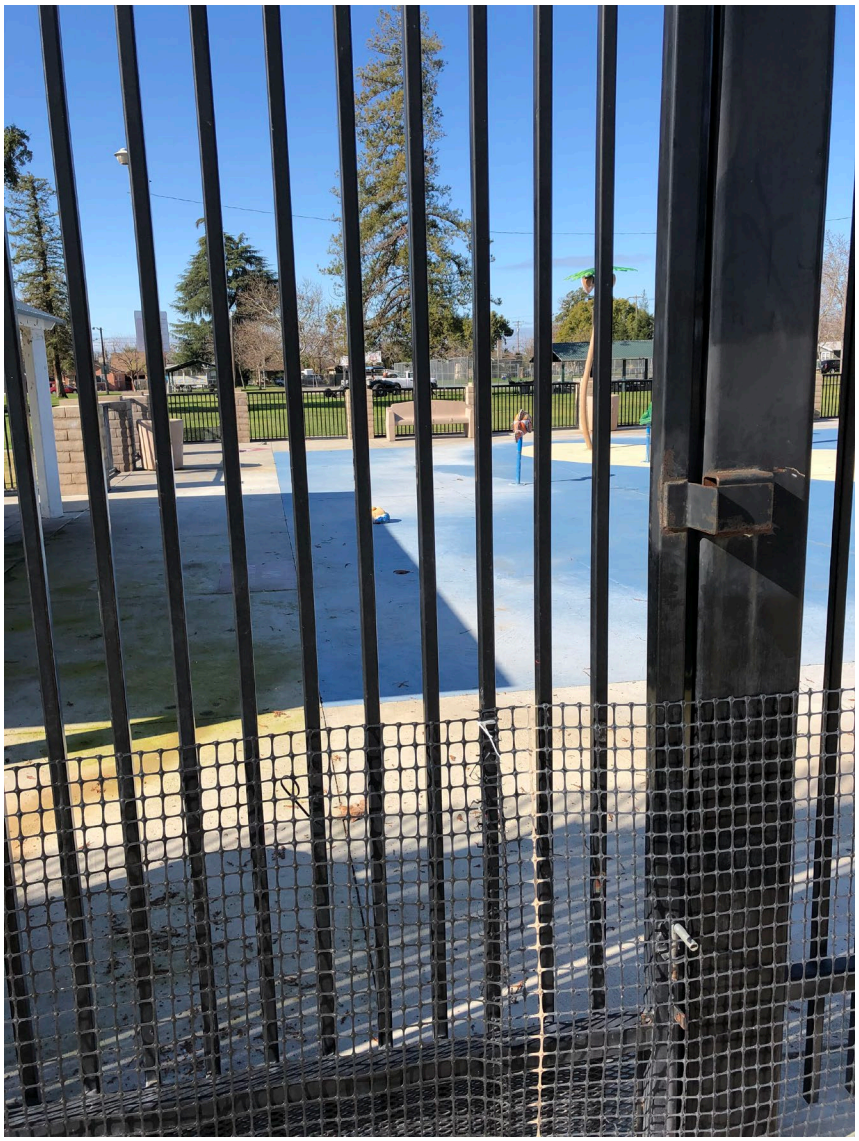
The perimeter fence for the facility is a tubular steel fence that staff report was last replaced in 2005. The current gates for the fence do not have self-closing and self-latching devices and open towards the swimming pool instead of away from the swimming pool. The gates are therefore in violation of Title 24, Chapter, 31B:

*Gate on Swimming Pool Perimeter Fencing*

The lack of self-closing and self-latching devices and the opening direction of the gates poses a safety risk. The gates should be updated to open away from the swimming pool and be fitted with self-closing and self-latching devices. The following estimate is for three (3) new gates to meet Title 24 enclosure and gate requirements.

**(Estimated Cost $45,000.00)**

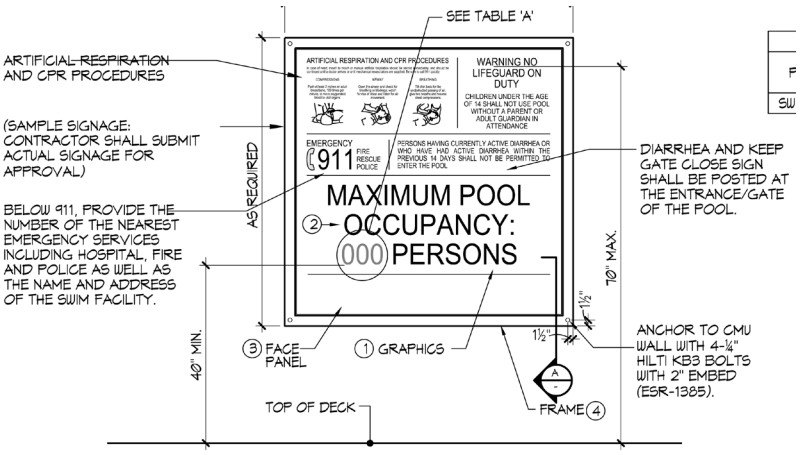
possess the required signage. Signs can be individualized or combined depending on the City's preference and determination for most effective delivery method for communication. For example, the required sign for diarrhea can be a stand-alone sign or incorporated into a sign that covers many sign requirements. The following estimate is for signage.

*Design Example of Combined Signage*

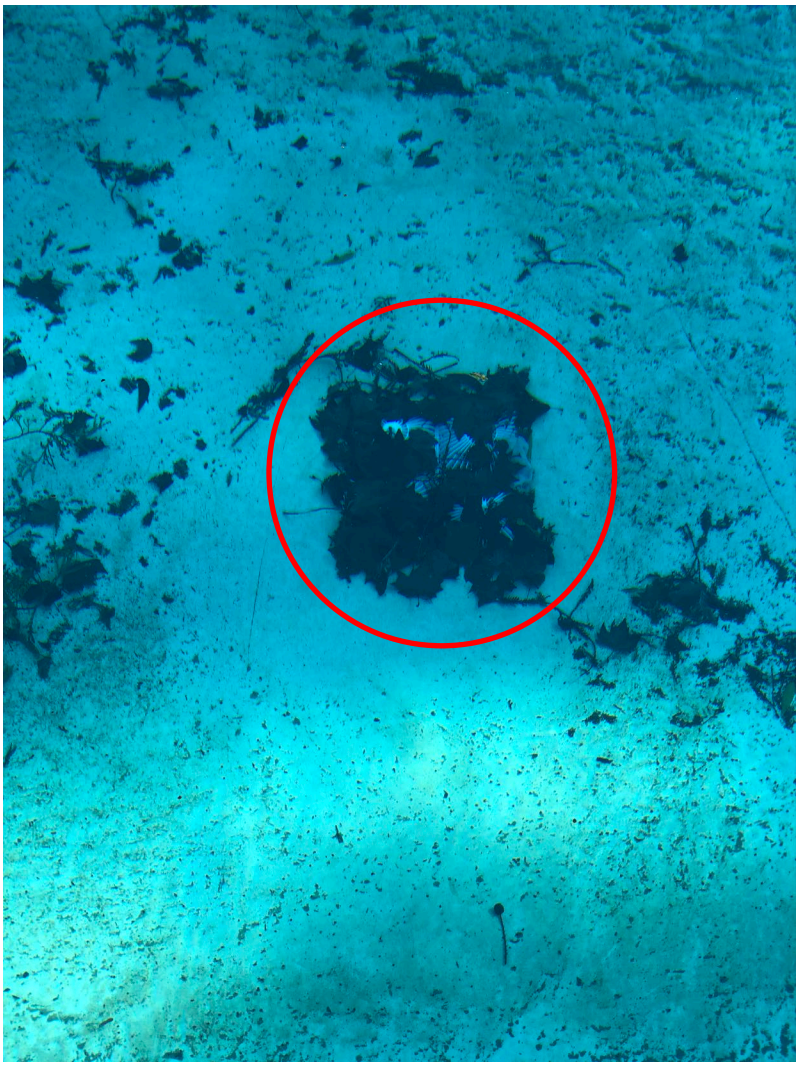
No as-built drawings for under pool piping were provided. Staff report that main drain grates were replaced in 2009 and then recalled in 2011. Staff also report that main drains are currently out of compliance. It is unclear whether this is related to drain cover expiration, incorrect drain cover equipment, or under pool piping being out of compliance. Based on the age of the swimming pool and the information provided about minor renovations it is likely that main drain interior sump dimensions are not in compliance. Further investigation would be required to identify issues and possible resolutions.

*Main Drain for Swimming Pool*

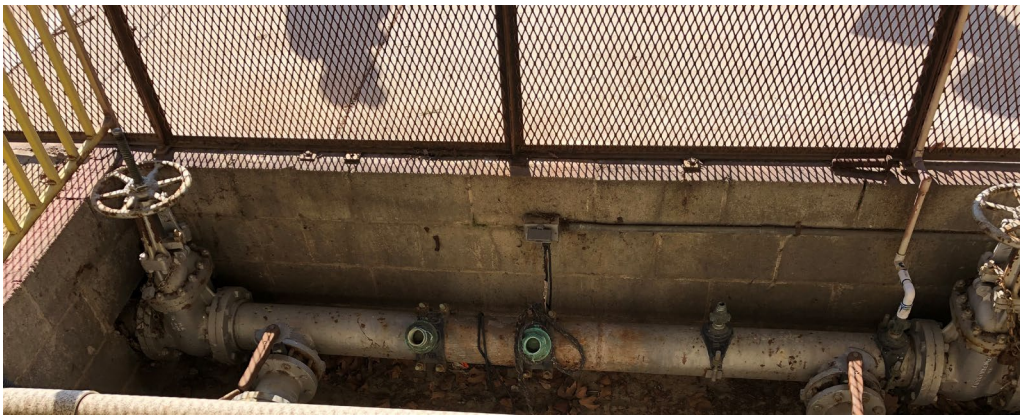
Piping for the swimming pool in the mechanical enclosure is a mix of materials that include: PVC, stainless steel, and steel. The steel piping, including the cast-iron piping, is rusting and corroding. With time the steel piping and connections will fail. Additionally, as the steel piping corrodes dissolved metal goes into the pool water and stains the pool surface. All steel piping should be replaced. Aquatic Design Group recommends schedule 40 PVC below grade and schedule 80 PVC above grade. An estimated cost for replacement piping is included in section 2.1 as piping would be replaced in concert with mechanical equipment replacement to ensure proper piping selections and pipe sizing.

*Steel Piping Corroding and Rusting*
